RESEARCH MEMORANDUM

INVESTIGATION OF THE FATIGUE STRENGTH OF
FULL-SCALE AIRPLANE WING STRUCTURES

By Dwight O. Fearnow

July 13, 1951

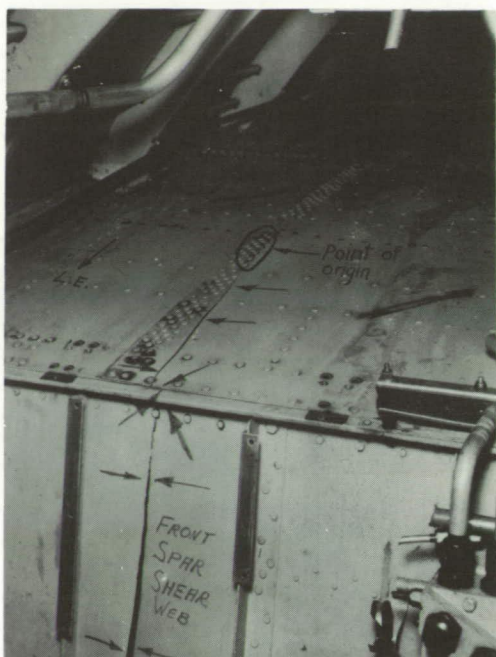
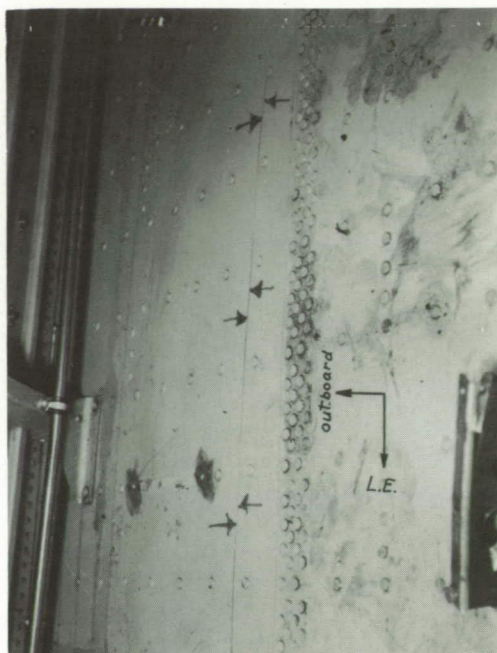
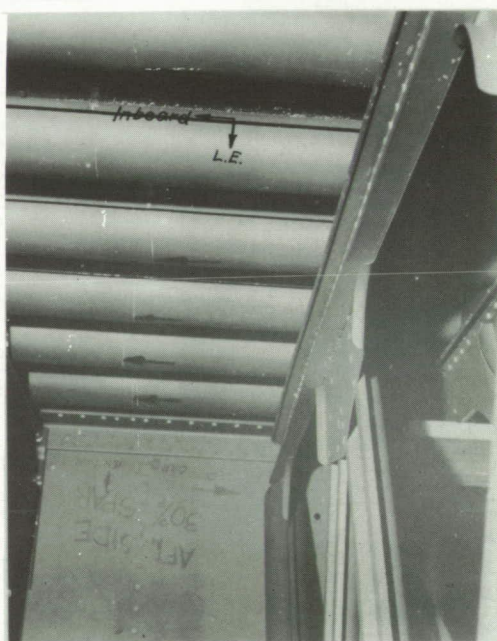
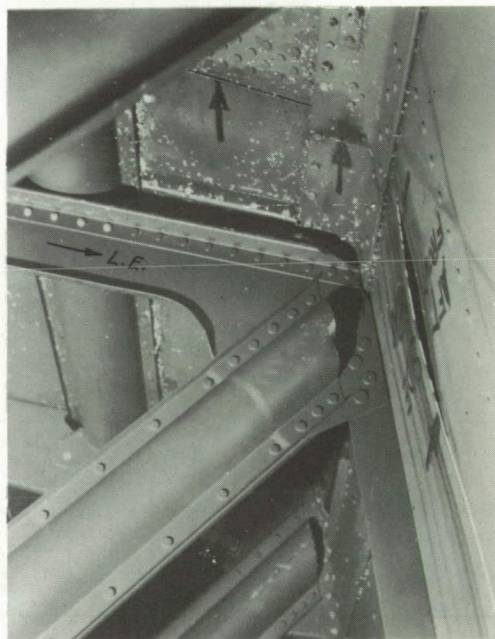
(a) View of crack looking aft.

(b) View of crack aft of point of origin.

(c) View of crack from inside of wing.

(d) View of crack showing failure of front spar flange.

Figure 7.- Four views of left wing showing crack 1 after loss of 50 percent of the tension material.

in figure 6. Figures 7, 8, and 9 are photographs of the cracks. Figure 7 shows four views of crack 1 after about 50 percent of the tension material had failed. Figure 8 shows crack 2 after about 10 percent of the tension material had failed. Figure 9 shows the length of crack 11 at the time of discovery. All three of these cracks originated at the same chordwise location in the riveted joints, two on the left side of the center line of the wing, the other on the right side.
